Continued Work on Machine Handling of Winegrape Picking Containers

**V Duraj, JA Miles, JM Meyers
July 2002**

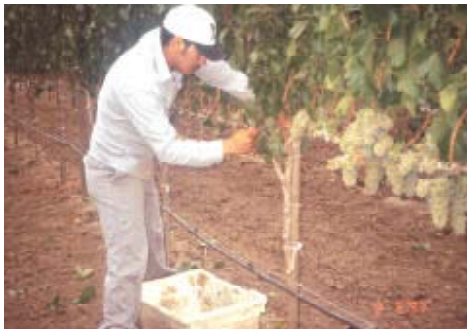
Figure 1: Worker cuts grape clusters.

To cut grape clusters from the vine, a worker stands facing the vine, reaches in with the non-dominant hand, grasps a grape cluster, and cuts it with a curved knife held in the dominant hand (Figure 1). As each cluster is cut, it is

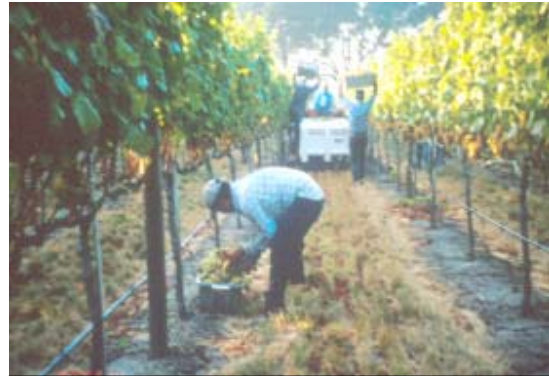
After harvesting the immediate area, the worker moves along the vine to reach new clusters. The worker either stoops to lift and place the container or pushes it with a foot with a sideways leg movement to slide it along. Often, the worker passes by a coworker who is harvesting the same vine row, requiring the worker to lift and carry the container perhaps ten or more feet. In either case, prior to moving the container, the worker usually stoops to gather up clusters that missed the container and occasionally to remove visible leaves that fell into the container (Figure 2).

Figure 2: Workers stoops to remove leaves.

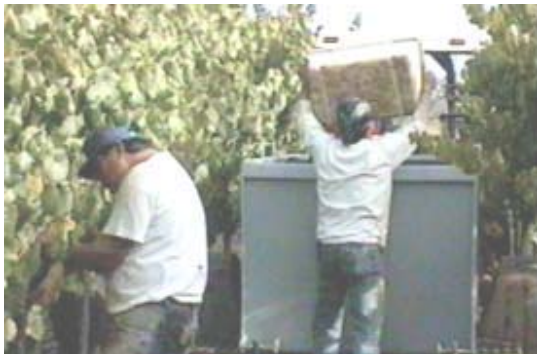
When the container is full the worker stoops to lift it and carries it to the gondola and empties the container into the gondola over its 50-inch high side (or a 40-inch high side if the smaller multiple bin system is used), as shown in Figures 3 and 4. Workers often carry tubs at overhead or shoulder height positions, in part because they will usually propel the grapes to less filled areas of the gondola.

Figure 4: Steel gondola on a trailer.

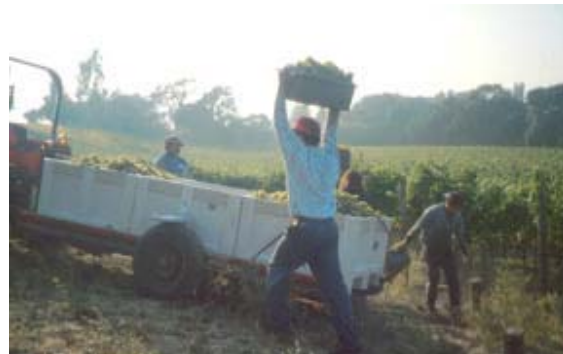
Figure 3: Multiple plastic bins on a trailer.

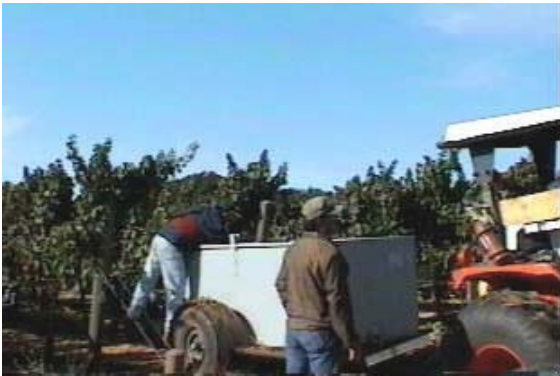
In order to keep the number of leaves in the trailer bins to a minimum, at least one worker works at the gondola removing leaves and poor fruit (Figures 5 and 6). The worker stands on narrow platforms attached to the sides of the trailer near the bottom of the bin, bends over and into the

Figure 5: Worker stands on narrow trailer step to bend over into gondola and remove leaves.

bin, and reaches as far as possible to grab and remove the leaves. However, until the bin is about one-third full, the worker may actually be standing inside the bin in a stooped posture in the grapes. Entry and exit also involve undesirable movements and postures.

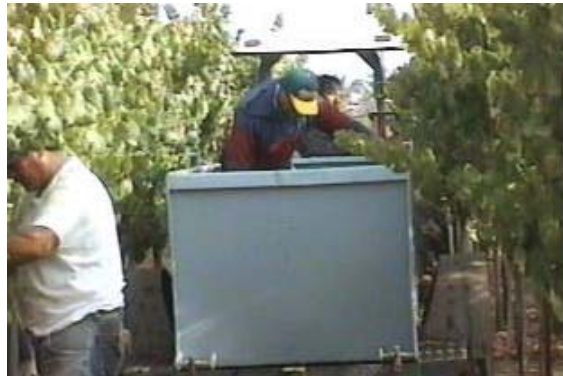
Figure 6: Worker stands inside gondola to remove leaves until it is about one third full.

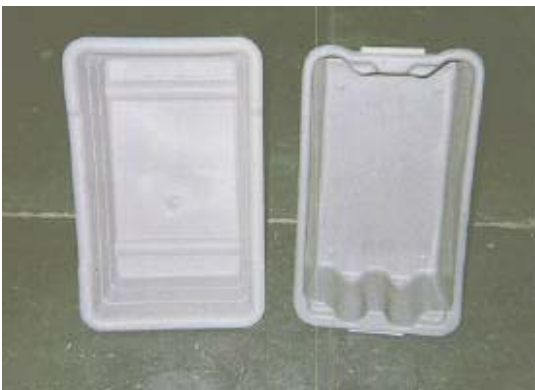
Figure 7: Pre- (l) and post-intervention (r) containers.

Previous work by Meyers et al. resulted in the introduction of a smaller picking container that reduced the average weight of a filled container from 57 pounds to 46 pounds. The container's acceptance by the industry is growing significantly, as evidenced by current cooperators use and feedback from the manufacturer. It is for this smaller container, the lift-carry-empty task, and the leaf-pulling job that the machine handling system was developed.

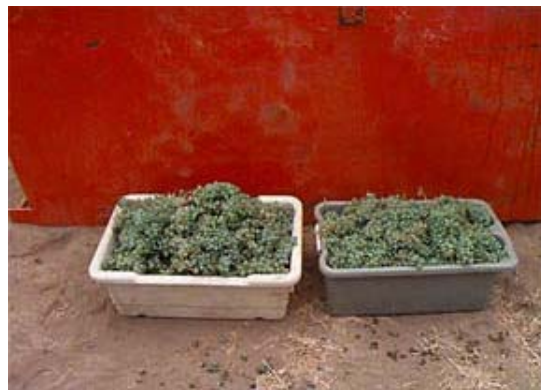
Figure 8: 57 pounds gross (l) and 46 pounds gross (r).

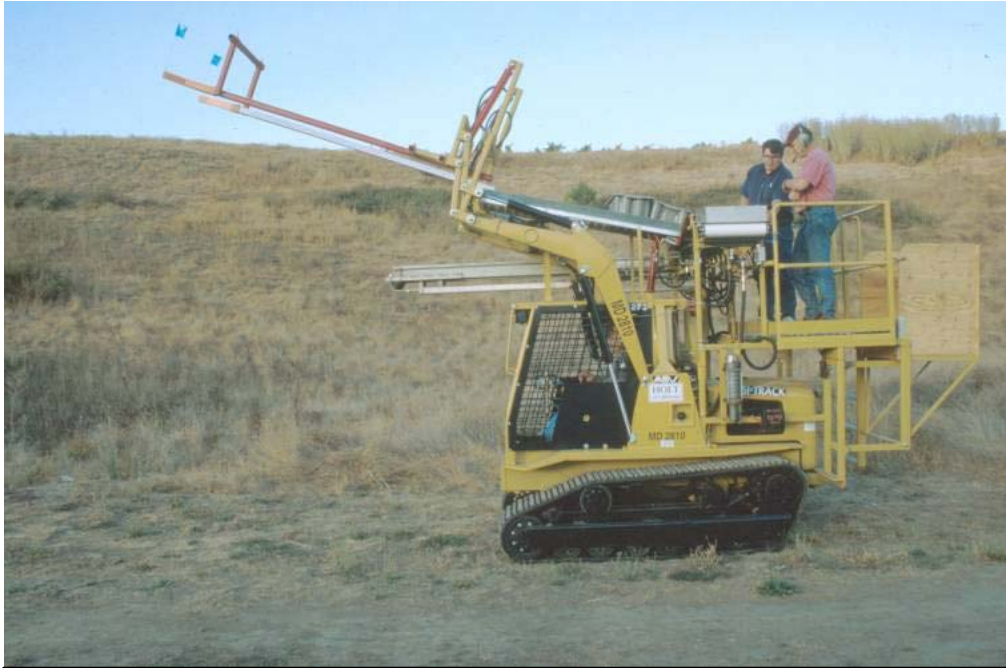
The machine handling concept was pilot tested with a forklift-style attachment and a workstation with conveyors all mounted onto a rubber-tracked reverse-traveling crawler tractor (Duraj et al., 2000).

Figure 9: Machine for handling picking containers. Staffing requirements included tractor driver, container handler, and leaf remover.

Designed as a set of attachments rather than an installation, the assemblies bolted or clamped to the tractor and utilized both of the on-board auxiliary hydraulic pumps with little modification to the existing plumbing.

The base tractor unit was an All Seasons Vehicles Model 2810. This tractor and the larger 4810 are a popular platform for vineyard pre-pruning equipment, but they play little or no role during harvest operations. The potential to make greater use of underutilized assets helped make the ASV an attractive selection for the study.

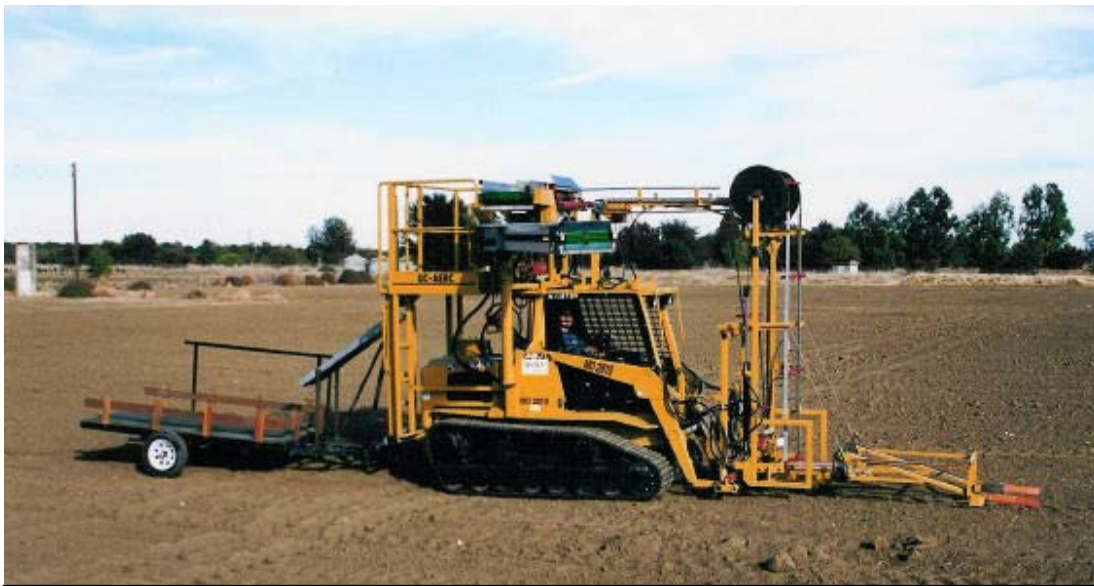
For the 2001 harvest season trials, significant changes were made to the container handling system. The primary change was the continuous pick-up device with side-shifting capability. This included hydraulically powered roller chain and v-belt conveyors with microswitch/relay logic controls. Additional changes included greater automation of the container dumper, a raised and forward-moved workstation, a wider discharge conveyor, and equipment for empty container handling that included a container collection trailer, an empty-container distributor, and a wash rack (Figures 10, 11, 12).

Figure 10: Modified machine for 2001 harvest trials.

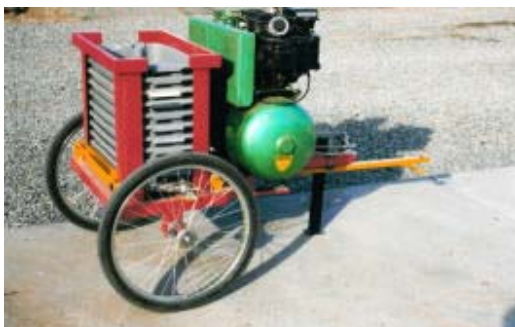
Figure 11: Container distributor without tow/storage vehicle.

The empty container handling system comprised of the trailer, distributor, and wash rack improved the efficiency of the related tasks compared to the previous year's trials. However, effective use of the distributor was compromised by the stickiness of the juice-covered containers and the need for precise prediction of the number of containers required depending on vine yield.

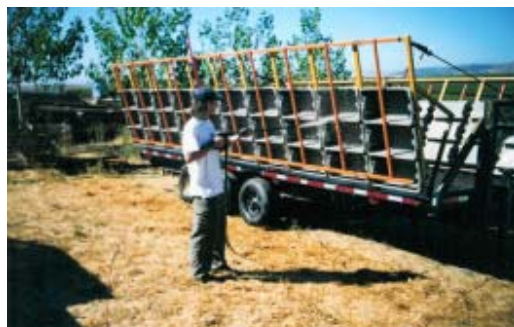
Figure 12: Portable trailer-based container wash rack.

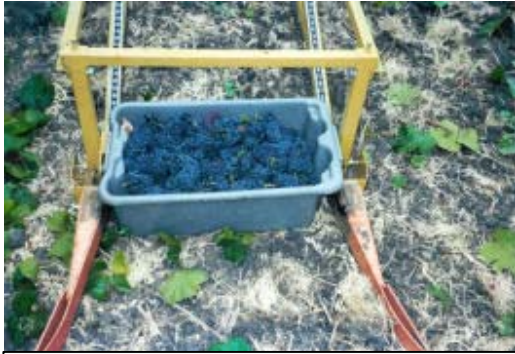
The modifications provided the following functionality, beginning with aligning the container into the pick-up device and lifting the container from the ground (Figure 13). This front-end device consists of #2040 conveyor roller chain with small angle iron tabs that contact the container on both sides behind the grips. The chains are powered from the tail shaft of the register infeed conveyor, which uses twist-lock type v-belt in UHMW guides (Figure 14). When a container reaches the

Figure 13: Container pick-up with centering guides.

Beginning with the pick-up device at ground level, the various mechanical and electrical systems operated well with only minor problems. The pick-up device hooked the containers as they came past the alignment guides and elevated them up onto the infeed conveyor even if the container was not perfectly aligned. Occasionally, the container would come off of the chain conveyor when one of the container's add-on grips broke free of its glued position. The container style being used is actually not ideal for machine handling but is being used because the cooperators are using this particular smaller container that was successfully introduced in an earlier weight-reduction study. The drive power taken from the tail shaft of the downstream v-belt conveyor was reliable. In fact, the v-belt conveyor served as an effective "shear device" during the occasional container jam by slipping and avoiding potential mechanical damage to the conveyor components.

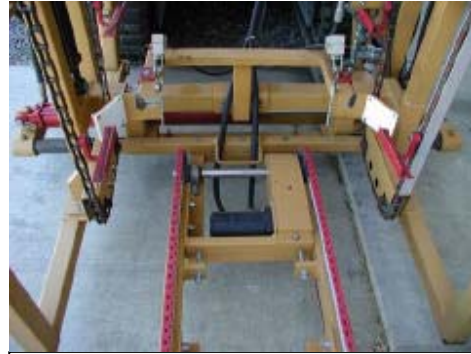
Figure 14: Register infeed conveyor; transfer to elevator.

The infeed conveyor, between the pick-up conveyor at the front and the elevator behind, effectively fed the lifted containers into the elevator register. Though the v-belt was not a positive transfer conveyor – the containers could slip atop the v-belt – its functionality was reliable on slight down slopes of about four percent grade through incline slopes of about ten percent. In the instances of excessive decline slopes, the machine operator would elevate the pick-up/infeed conveyor assembly with the hydraulically powered cable lift feature.

The register, the place where the container stops horizontal travel and was engaged into vertical travel, functioned reliably. The precise alignment of the elevator attachment sprocket guides held during the entire season and functioned reliably at varying machine angles relative to horizontal and pick-up device angles relative to the machine. The series-wired triggering microswitches also functioned reliably, except occasionally when an empty container just did not have enough tractive force atop the v-belt to maintain the microswitch(es) long enough to latch the logic relay.

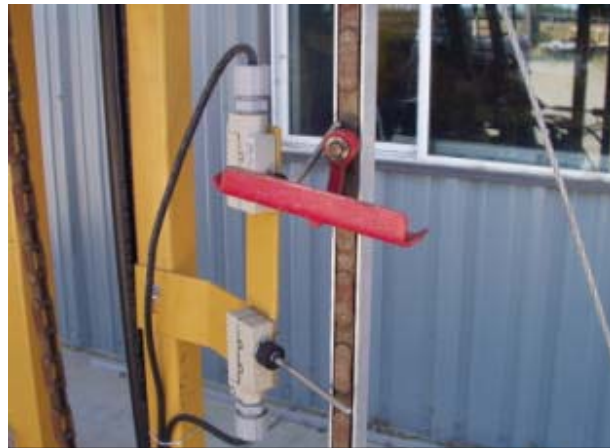
alignment stops it also triggers the microswitches at the back. When these series-wired microswitches are triggered the infeed drive stops and the C2050-chain elevator starts. The elevator attachments (Figure 15) engage the container, and the elevator indexes up thirty-six inches. When it stops, the infeed/pick-up drive restarts to repeat this cycle. The operator in the tractor cab may depress a momentary switch to simulate a container in the register, for purposes of clearing the system of containers.

Figure 15: Container "grabber" attachment.

The elevator worked reliably, except when a container came through with an incorrectly positioned add-on grip (due to glue failure). In such cases, the container had as much chance to process successfully as it did to slip off one of the attachments and create a jam and grape mess below. This again was an issue with the add-on grips that in normal hand harvest practices did not need to be glued. The retrofit effort utilized hot-melt glue to join PVC pipe to the polyethylene-based plastic containers. The elevator chain attachments otherwise worked very well even under highly agitated motion of the elevator during combination side-shifting, forward-backward terrain induced machine motion, and vertical start-stop travel.

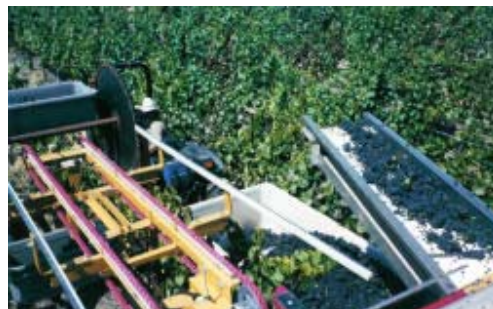
As a container travels over the top of the elevator it transfers onto a v-belt conveyor (Figure 16) that delivers the container to the dumper. This conveyor includes microswitches at both ends for queue control. The dumper-end of the top conveyor pivots, as does the elevator-end, to accommodate the side-shifting capability of the entire front-end pick-up/infeed/elevator attachment. The pivot at the elevator-end (Figure 17) also allows the front-end to be raised for clearance during trailer loading and for machine maneuvers in narrow headlands.

Figure 16: Top-side transfer conveyor.

The transfer between the top sprockets and the topside transfer conveyor was also quite reliable. The occasional jam that occurred at the transfer point was usually caused by a misaligned container due to add-on grip issues, but had not fallen off during its elevation. This transfer junction operated reliably through the entire two-foot side-shifting range of the elevator.

The top-side queue conveyor operated well, except when a container transferred from a side-shifted elevator and then bumped up against the side guide rail to such an extent that the container began a twist. The v-belts could not provide the necessary traction force to prevent the onset of such rotation, which was exacerbated under slope conditions. The microswitch-based relay logic controls effectively controlled the flow of containers from the elevator, through the top side transfer conveyor and into the dumper mechanism.

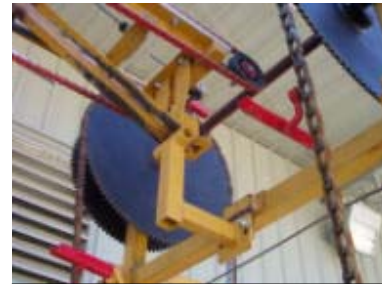
The front-end side-shift is capable of twenty-four inches total side-to-side travel, actuated by a hydraulic cylinder that is controlled by the existing tractor's joy-stick control for an available bucket loader attachment. The tractor's lift-arm function is plumbed through a double-selector valve to operate the lift arms for front-end lifting as described earlier or to elevate and lower the pick-up/infeed elevator device.

Figure 17: Elevator pivot.

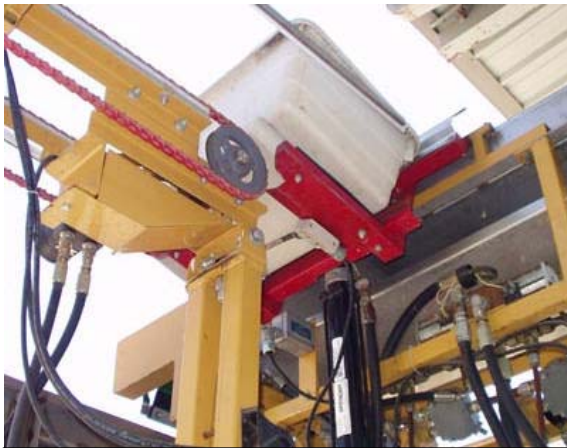
Figure 18: Container dumper device.

The container(s), lifted by the front-end and top-side attachments, reach the dumper where it triggers a microswitch. Depending on the full-off-semi setting of a selector switch, the dumper will automatically actuate, not actuate, or actuate with the attendant's depression of a momentary button. The actuated dumper inverts the container over the sorting conveyor and the attendant grasps the emptying container and places onto the chute leading to the collection trailer. The dumper returns to accept another container as soon as the current container separates from the dumper.

The dumper mechanism operated reliably in full automatic and semi-automatic modes. In full automatic mode, as soon as a container entered the dumper far enough to trigger a calibrated microswitch then the dumper cycle would latch and maintain until the container separated from the dumper. In semi-automatic mode, for when additional sorting time was required for each container of grapes, the dumper would actuate and latch only when a momentary pushbutton was pressed after a container was situated in the dumper.

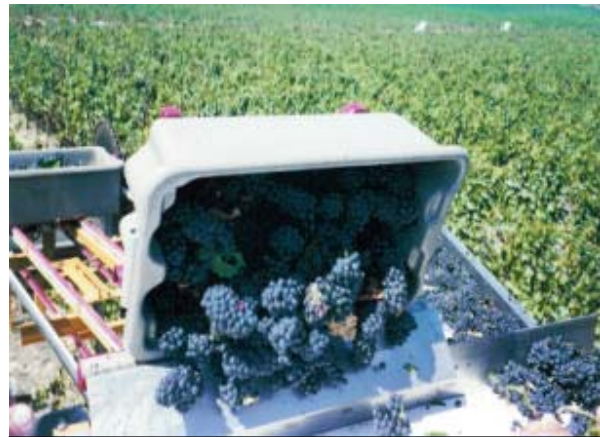
Figure 19: Container at end of dumper travel.

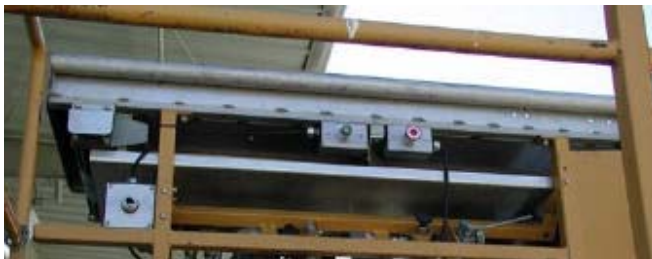
Figure 20: Workstation controls: selector switch (l), momentary pushbutton for semi-automatic function (m), machine emergency stop (r). Difficult to see, but present, are the manual valves for belt conveyor run/stop and the directional valve for the discharge conveyor's swing-out positioning cylinder.

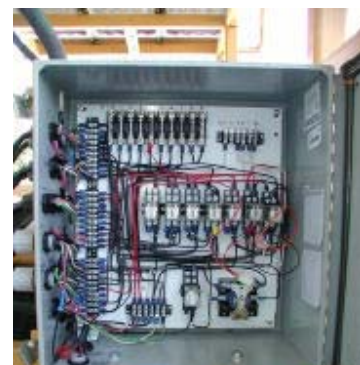
Figure 21: Electrical relay panel.

Generally, the mechanical handling was successful. The hydraulic power supplied by the existing auxiliary pumps was adequate. The electrical relay and logic functioned without failure, except for one occasion when water shorted out the dumper selector switch. The machine's throughput performance was compromised primarily by limited leaf sorting capability: often the controls would be placed into semi-automatic, compromising the continuous-container-conveying capability, in order to have additional time to remove all of the leaves. Expected installation of provisional mechanical leaf removal equipment did not occur prior to testing, though structural design
